## **RAILWAY INVESTIGATION REPORT**

**R99T0147**

### **CROSSING ACCIDENT**

**BELLAMY, ONTARIO**

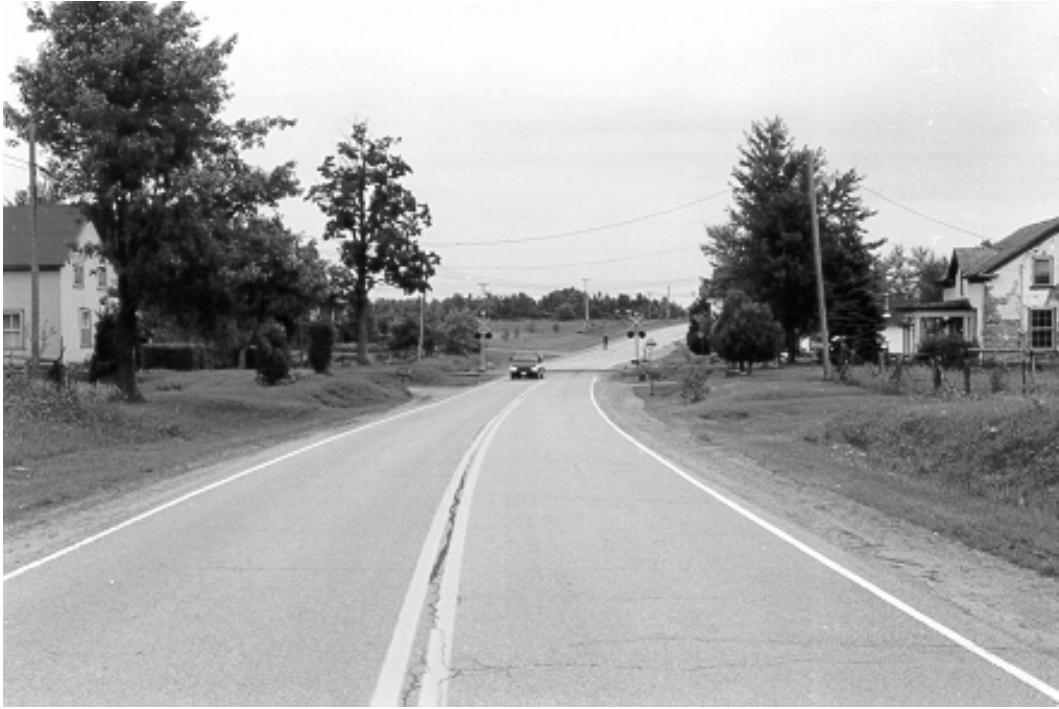
Figure 1 - Crossing at Mile 18.13 of the CPR Brockville Subdivision, facing east

Sight-lines in all quadrants were poor due to obstruction by rock cuttings, vegetation, and private dwellings. A vehicle entering the crossing from the west must be within 6 m (20 feet) of the track for the driver to see 244 m (approximately 800 feet) down the track to the south. Farther than 6 m from the track, the sight-line was completely blocked. Average daily traffic volume is 500 vehicles, which is classified as low by the Ministry of Transportation of Ontario (MTO). Passenger train schedules vary from day to day. On Saturday, June 5, six passenger trains were scheduled to travel through the crossing. Between Sunday and Friday, two freight trains per day pass through the accident location. No freight trains are scheduled on Saturdays.
